Appendix 12A: Policy Context, Survey Methodologies and Evaluation of Ecological Importance

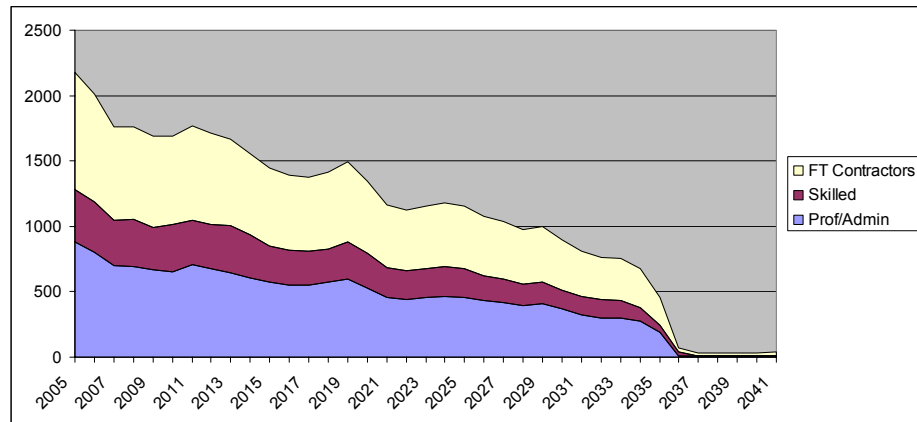
Figure 2.1: Staffing Changes from 2005 to 2041

As the Dounreay site is currently undergoing decommissioning, there is natural wastage of permanent staff, which is reported in the document 'Lifecycle Baseline, Annex 3: Dounreay Site'. The document summarises the detailed Lifecycle Baseline plan for Dounreay, which was submitted to the Nuclear Decommissioning Authority on 30 September, 2004, and details the natural staff decline to the end of the facilities lifespan. Figure 2.1 illustrates the decline graphically with Table 2.1 providing the actual figures over the 5 year analysis period.

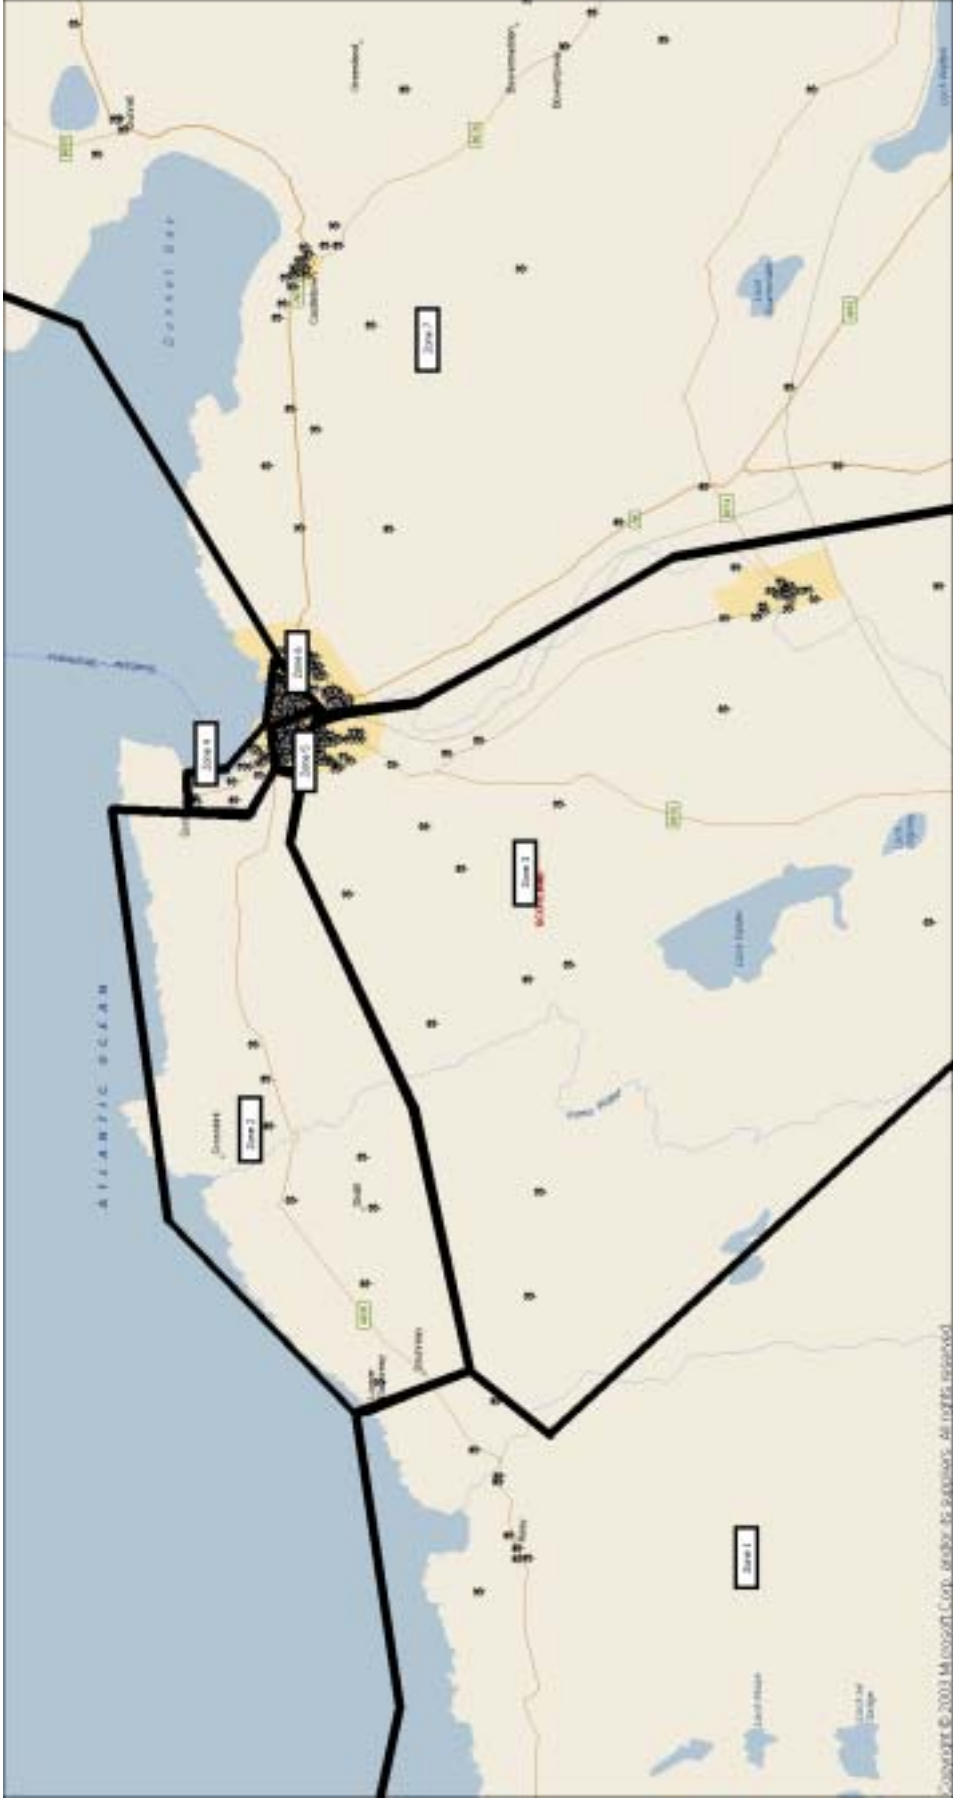
Copyright © 2003 MapSource Corp. and/or its suppliers. All rights reserved.
Figure 3.2: Detailed MapPoint Distribution Zones

Figures 3.1 and 3.2 detail the MapPoint distribution zones.

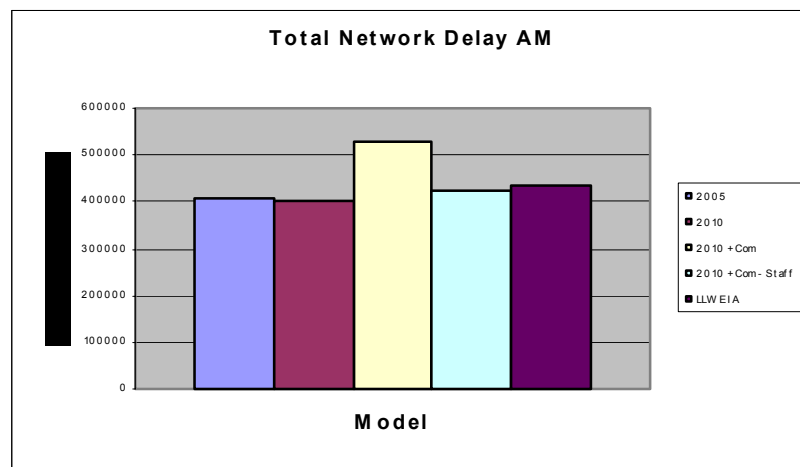
Figure 5.1: Total Average Network Delay (Secs) AM

Model Year	2005	2010	2010 + Com	2010 + Com -Staff	2010 LLW EIA
	414957	398226	538543	433054	429130
	396804	398226	517812	418743	434770
	409838	408340	536264	425533	443821
Total Delay (Avg)	407200	401597	530873	425777	435907

From the tables and figures above it can be seen that both the AM and PM total network delay are less than those associated with the 2010 with committed development.

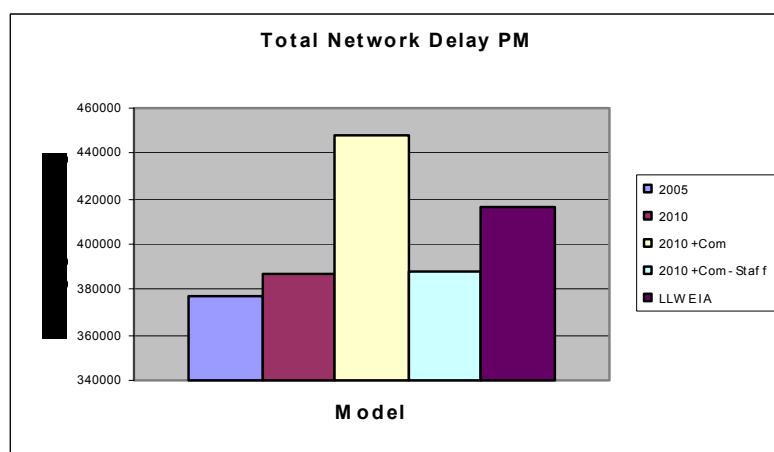
Figure 5.2: Total Average Network Delay (Secs) PM

Model Year	2005	2010 + Growth	2010 + Com	2010 + Com -Staff	2010 LLW EIA
	379762	400807	447936	383201	416942
	375464	381939	447936	394186	406383
	375923	378990	447936	386095	426383
Total Delay (Avg)	377050	387245	447936	387827	416569

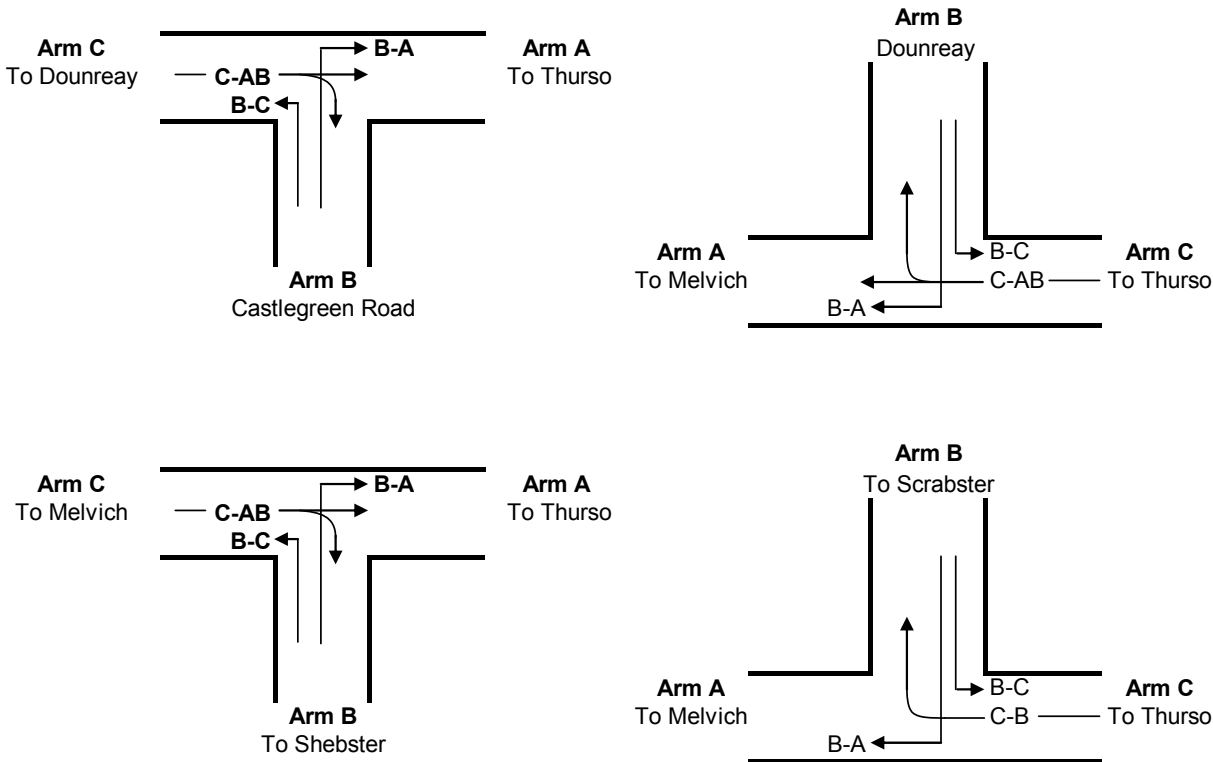
Table 5.11: PICADY Movements

It can be seen in the PM peak period that the busiest arm is movement B-C at the site access but at 0.519 RFC, it has not exceeded its practical capacity of 0.85 RFC. All other movements are well within their design capacity. It should be noted that in the PM peak period, all junctions are working more, or as, effectively than model year 2010 + committed development.

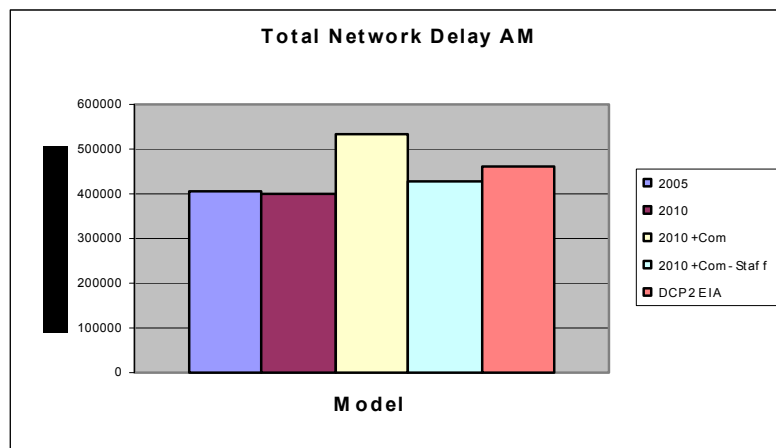
Figure 6.1: Total Average Network Delay (Secs) AM

Model Year	2005	2010	2010 + Com	2010 + Com -Staff	DCP2 EIA
	414957	398226	538543	433054	451998
	396804	398226	517812	418743	469218
	409838	408340	536264	425533	457956
Total Delay (Avg)	407200	401597	530873	425777	459724

From the tables and figures above it can be seen that both AM and PM total network delay totals are less than those associated with the 2010 + committed development.

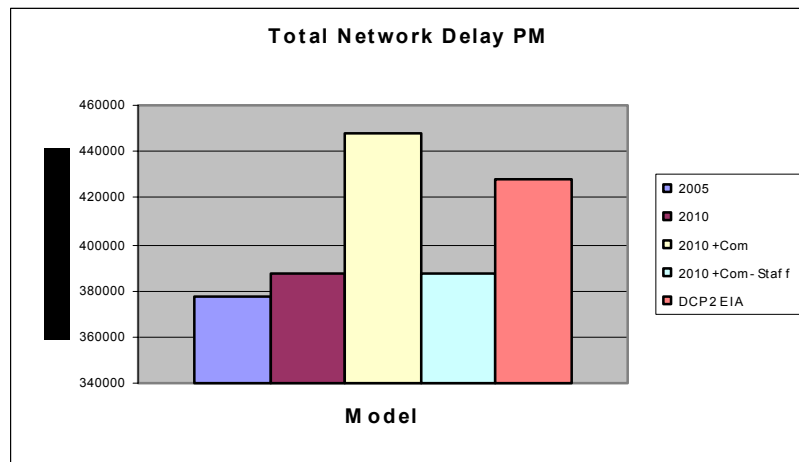
Figure 6.2: Total Average Network Delay (Secs) PM

Model Year	2005	2010 + Growth	2010 + Com	2010 + Com -Staff	DCP2 EIA
	379762	400807	447936	383201	424927
	375464	381939	447936	394186	425971
	375923	378990	447936	386095	434211
Total Delay (Avg)	377050	387245	447936	387827	428370

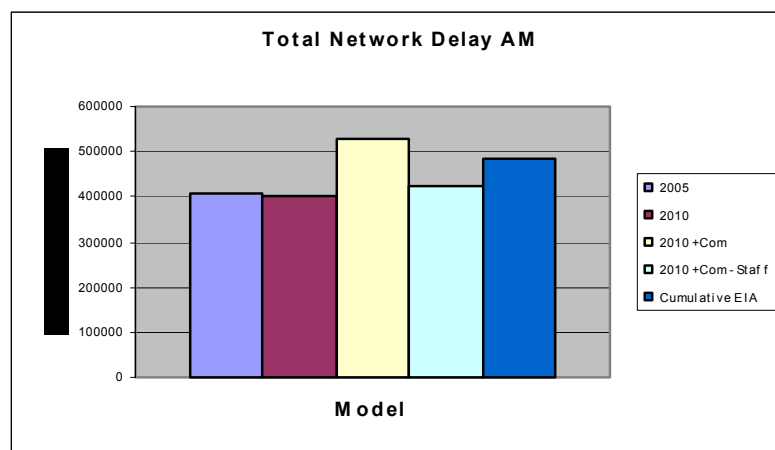
Figure 7.1: Total Average Network Delay (AM)

Model Year	2005	2010	2010 + Com	2010 + Com -Staff	Cumulative Analysis
	414957	398226	538543	433054	485258
	396804	398226	517812	418743	487841
	409838	408340	536264	425533	488045
Total Delay (Avg)	407200	401597	530873	425777	487048

From the above it can be seen that the AM peak period total network delay is less than 2010 + committed development. The PM results are slightly above that recorded on the PM 2010 model with committed development rising from 447,936 seconds to 459,479, equating to a 2.5% increase. This is partly due to the fact that the exiting traffic in the PM peak was lower than that which arrived in the AM peak, and in response a lower amount of vehicles was removed from the full time vehicle numbers to take into account the aforementioned staff wastage. No vehicle reduction was applied to the total contractors vehicles leaving in the PM peak so as to produce a robust analysis.

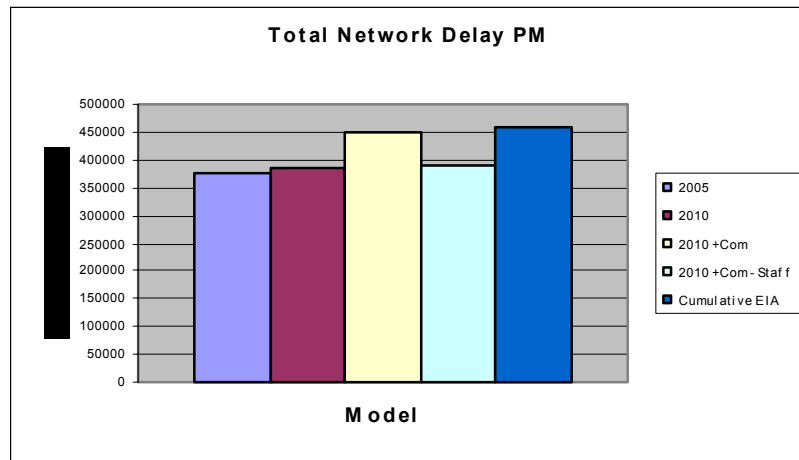
Figure 7.2: Total Average Network Delay RFC (PM)

Model Year	2005	2010 + Growth	2010 + Com	2010 + Com -Staff	Cumulative Analysis
	379762	400807	447936	383201	461872
	375464	381939	447936	394186	460951
	375923	378990	447936	386095	455614
Total Delay (Avg)	377050	387245	447936	387827	459479
