Land Remediation Department	Reference:	LRP(07)P031	
	Issue:	1	
	Date:	25 October 2007	
	File No:	D1071.A08046	
<p>REPORT ON AN UNUSUAL PLASTIC ITEM FOUND ON SANDSIDE BEACH ON 15TH DECEMBER 2006</p>			
<p>ABSTRACT</p> <p>During a routine survey for radioactive particles on Sandside beach in December 2006, a contaminated object was detected. In-situ measurements confirmed that the plastic-like material contained ^{137}Cs and the object was transferred to the Dounreay laboratories for photographing and further analysis. The contamination was shown to be inhomogeneous and was concentrated in an area occupied by what looked like a whitish-coloured plastic bottle with a small rubber cap. Isolation of this item confirmed that almost all of the ^{137}Cs activity was associated with it. In order to obtain further information on the contamination fingerprint, actinide analyses were carried out. Radionuclide ratios (^{137}Cs, ^{241}Am, ^{238}Pu, $^{239+240}\text{Pu}$) obtained for two portions of the item were compared to other known or estimated fingerprints, but no clear match was obtained. The bulk object which contained the contaminated item was observed to float in seawater and could the

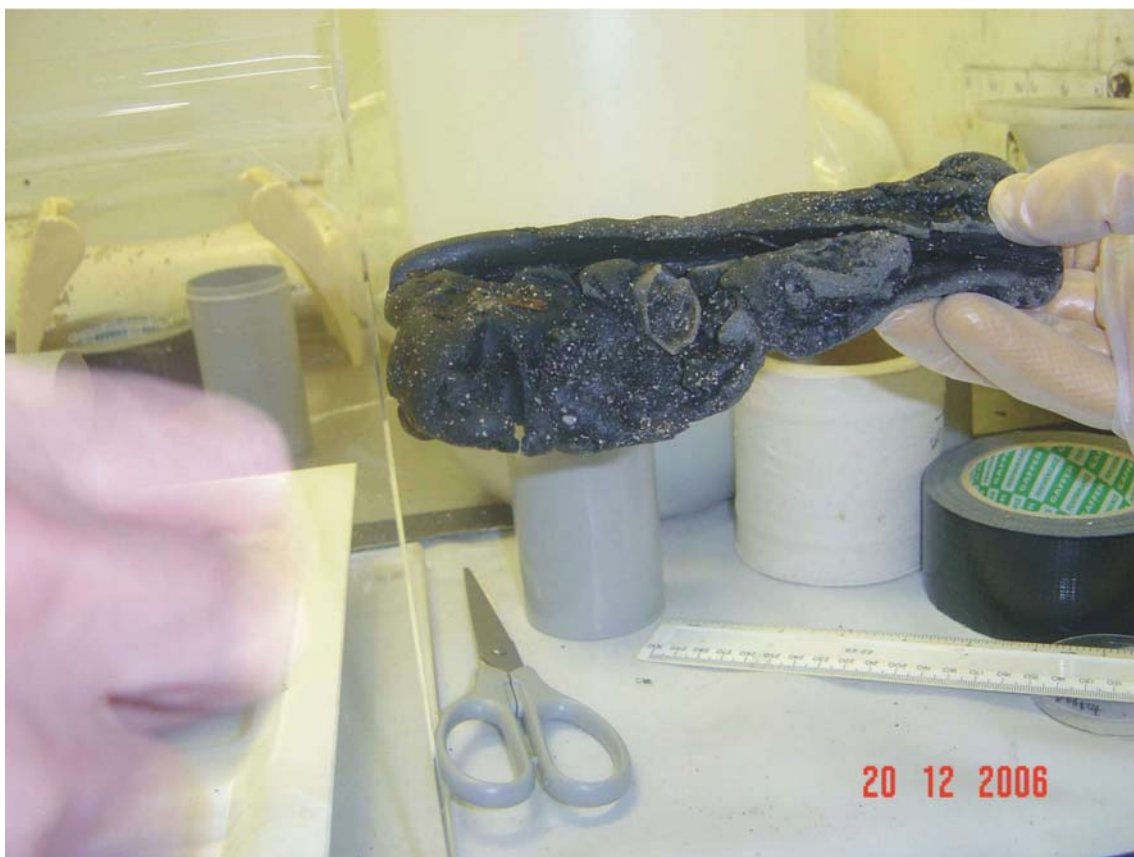
Figure 1 - Item retrieved from Sandside beach on 15th December 2006.

During a routine survey at Sandside beach on the 15th December 2006 at approximately 1335, the alarms on the beach survey vehicle were triggered by a plastic-like item (Figure 1). It was found towards the eastern end of the beach, lying in seaweed close to the water's edge at coordinates 296726, 965472. Mr Minter from Sandside estate was contacted and his representative, Mr W. McIvor attended the scene. The radioactive contaminant which triggered the alarm was confirmed as ¹³⁷Cs using a handheld spectrometer. The item along with entangled flotsam such as seaweed was recovered to Dounreay, where it was analysed by UKAEA chemistry support services (CSS).

A selection of photographs of the item are show in Figures 1, 2, 3 and 4. The main bulk of the item is black in colour and appears to have been melted and deformed, perhaps due to fire or being near some other heat source. In the area near the centre of the bulk item can be seen a whitish item at the top of which is a small black rubber-like cap (Figure 2) which was removed for closer examination (Figure 3). It is not clear if this whitish item was originally part of the bulk material or has subsequently become fused to it. The cap was able to be stretched during removal and appears to have been deliberately shaped with a bevelled appearance and is ridged near the middle. Removal of this cap revealed a flange-like end to the whitish material (Figure 4). The beta count rates were largely confined to this area of the bulk material where the whitish item was located. The ¹³⁷Cs contamination could be associated with it, or could be associated with a particle trapped in the bulk black

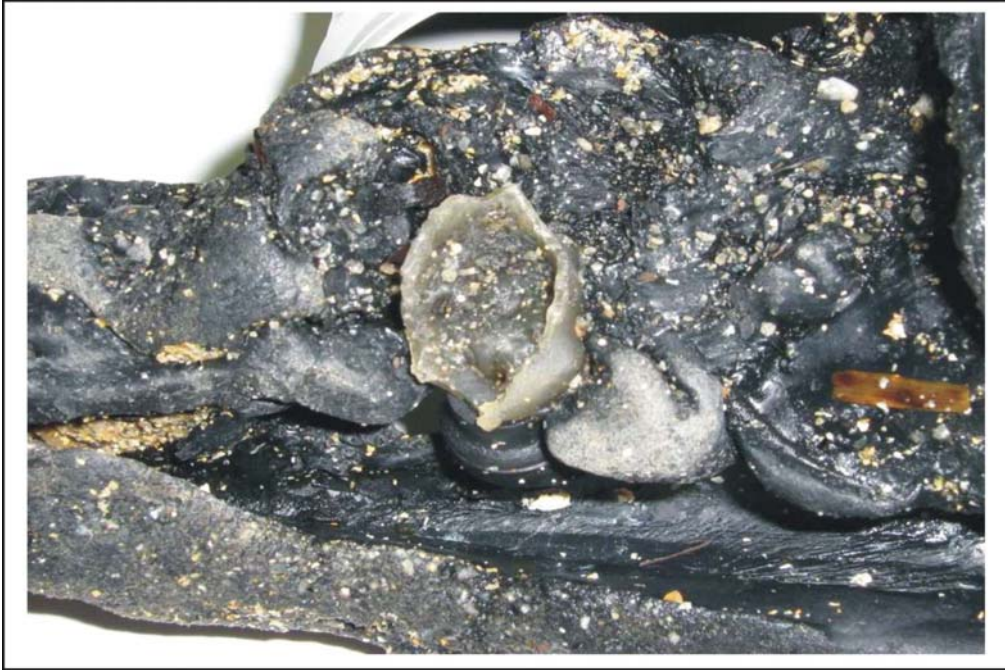
Figure 2 - Close up of whitish item near middle of bulk material. Rubber-like cap is visible behind the white material

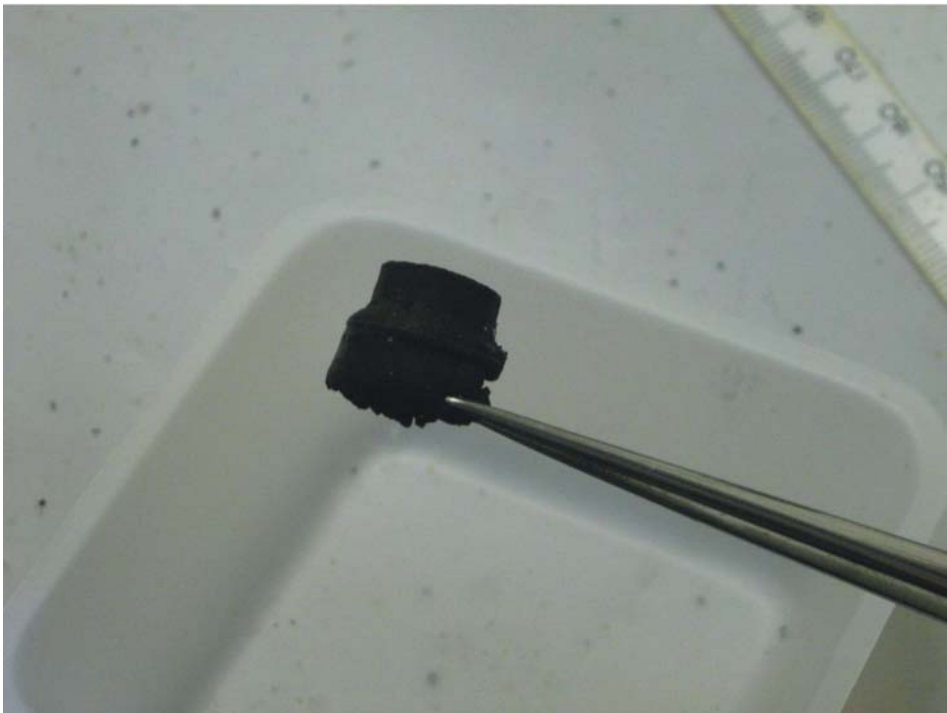
Figure 3 - Rubber-like cap after removal from whitish item

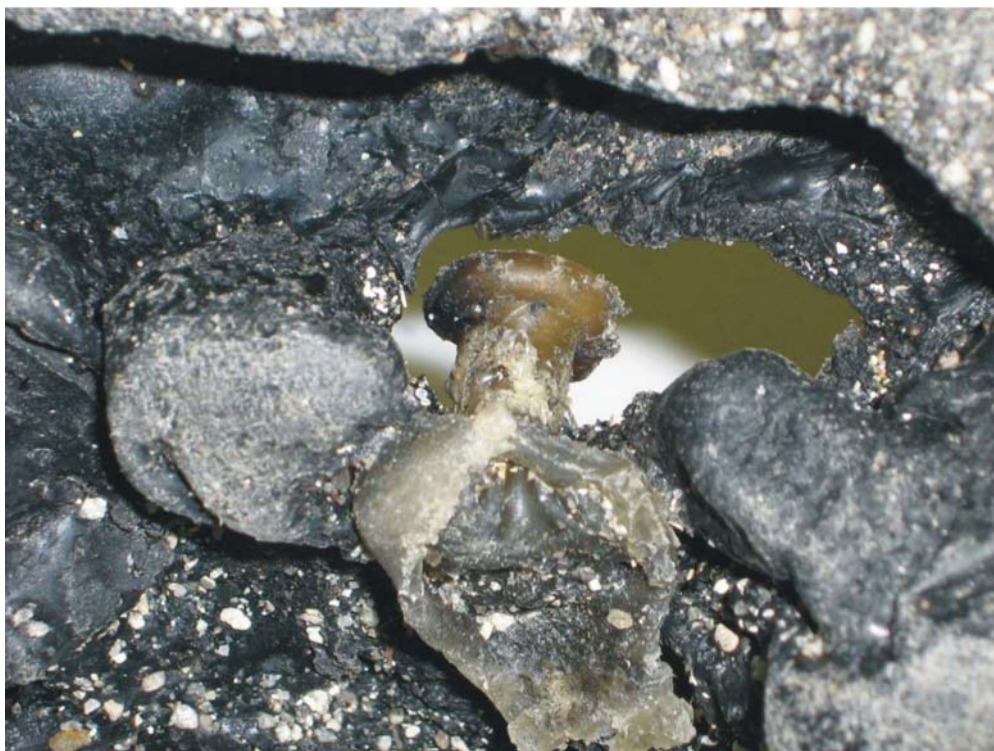
Figure 4 - Close up of whitish item after removal of cap

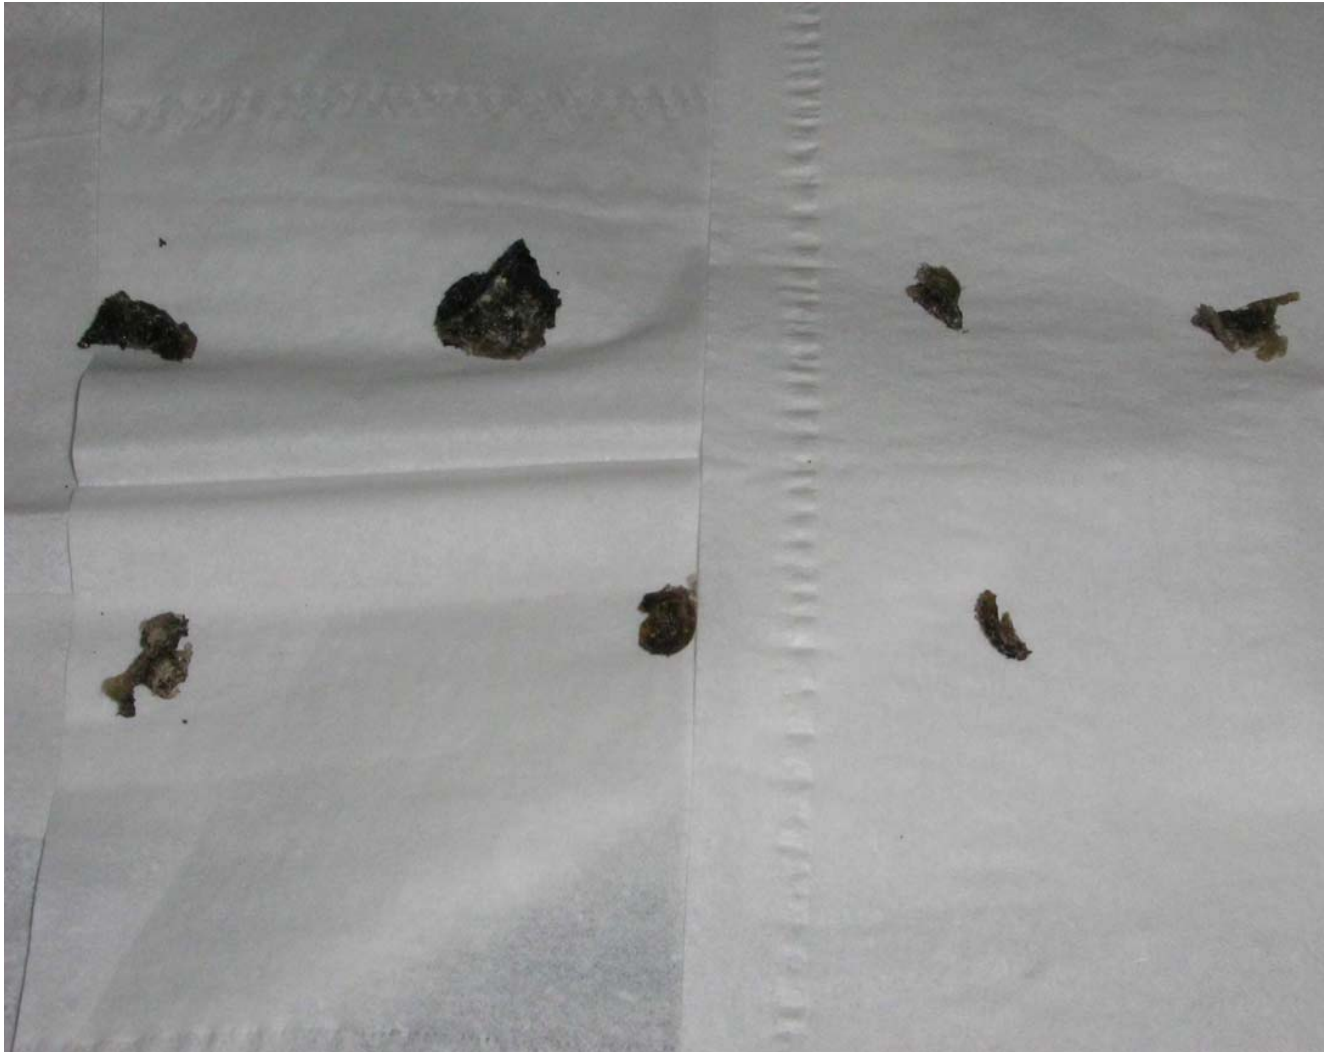
Figure 5 - Pieces of plastic separated from the active area. Each piece contained ^{137}Cs and ^{241}Am

Further cutting was carried out on the most active part of the plastic i.e. the smaller whitish item within the larger black bulk material. Using a handheld probe to guide where the activity resided, the active item was cut into seven pieces, which ranged in count rate from 40 to 1000 cps. Only small count rates from the residual black material of about 10 - 15 cps were recorded, therefore almost all the activity resided in these 7 pieces.

The cps, ^{137}Cs and ^{241}Am levels in each piece is provided in Table 4. The highest activity piece (piece 1) is the one in the centre of the bottom row in Figure 5.
