### ‘UNUSUAL’ OBJECTS WITH RADIOACTIVE SIGNATURE

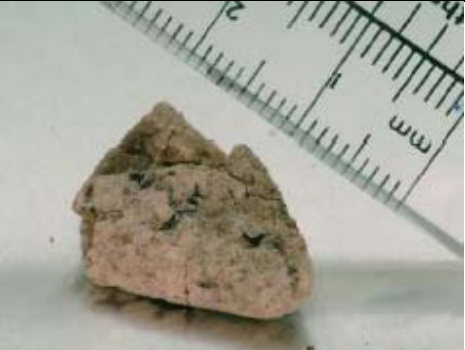
Date found	Area found	Photograph	Additional comments
02.03.2005	Dunnet beach

<p>Small stone-like object found wrapped within a tight ball of flotsam including seaweeds, string and plastic. SEPA gave permission to analyse the item using non-destructive methods only. The item was measured in the Dounreay laboratories and found to contain about 20,000 Bq of <sup>137</sup>Cs. The <sup>137</sup>Cs appeared to be present over the surface of the item rather than present as a single hot spot.</p> <p>The object was sent to an external laboratory for further geochemical analyses and a report submitted to SEPA. The external lab analyses show the item is composed of polyethylene. The origin of the <sup>137</sup>Cs contamination and of the substrate has not been established. <sup>137</sup>Cs is widely found in the environment as a result of fallout from weapons testing, the Chernobyl accident and discharges made under authorisations from the nuclear industry. Tests carried out by UKAEA would discount the activity on this object being related to the Chernobyl accident.</p>

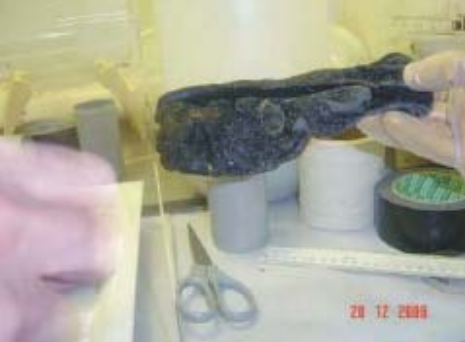
15.12.2006	Sandside beach

<p>A plastic-like item was discovered entangled in flotsam and seaweed. The object appears to be made of a dark-coloured plastic and seems to be partly melted or burnt. It measures about 8" x 3" and is over 1" thick. Following initial analysis, the object was found to contain <sup>137</sup>Cs at a level of about 4,600 Bq which was found to be more concentrated in the central area. Further tests have been discussed with Sandside Estate and are being carried out.</p>
