Post-closure Decommissioning Intermediate Decommissioning

Dounreay Materials Testing Reactor

Background

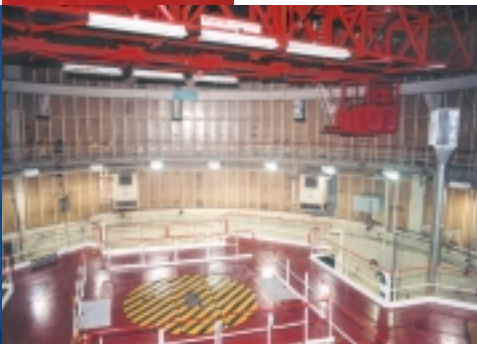
Completion of 1996-2003 Decommissioning phase

In 1996 contractors commenced work within D1250 to remove all redundant equipment and generally prepare D1250 for passive care and maintenance pending final demolition during a future phase of the Dounreay Site Restoration Plan.

- Removal of drummed radiological waste and stored as LLW
- Removal of bulk waste
- Removal of redundant material and equipment
- Crane and Lift immobilised
- All remaining original services disconnected/isolated
- New lighting system installed which is controlled from the personnel airlock

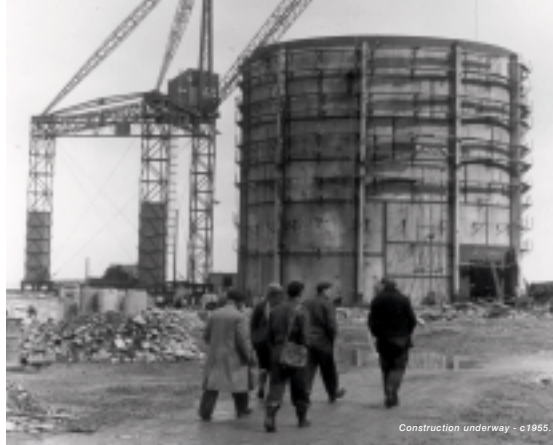
Construction underway - c1955.

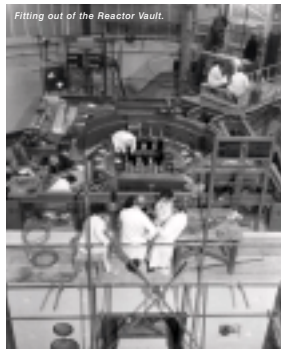
Fitting out of the Reactor Vault.

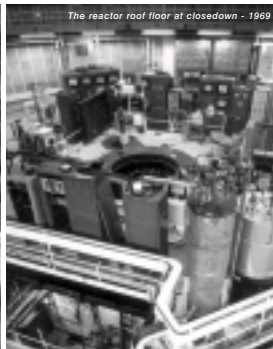
The reactor roof floor at closedown - 1969
